# Analysis of the Fracture Failure of ST90 Coiled Tubing

SHINDA(TANGSHAN) CREATIVE OIL & GAS EQUIPMENT CO., LTD, China

## ABSTRACT

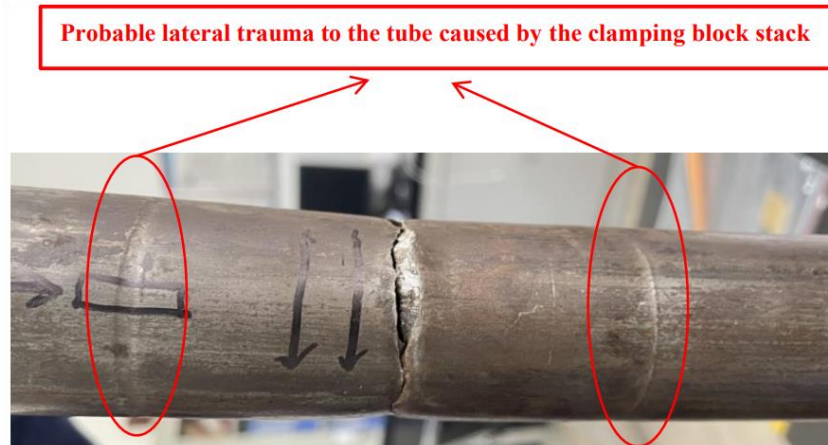
The broken tubes with obvious trauma were numbered A1, and the remaining tubes were numbered A2, to analyze the sample.

**Figure 1.** Causing lateral damage exist at both ends of the fractured tubing

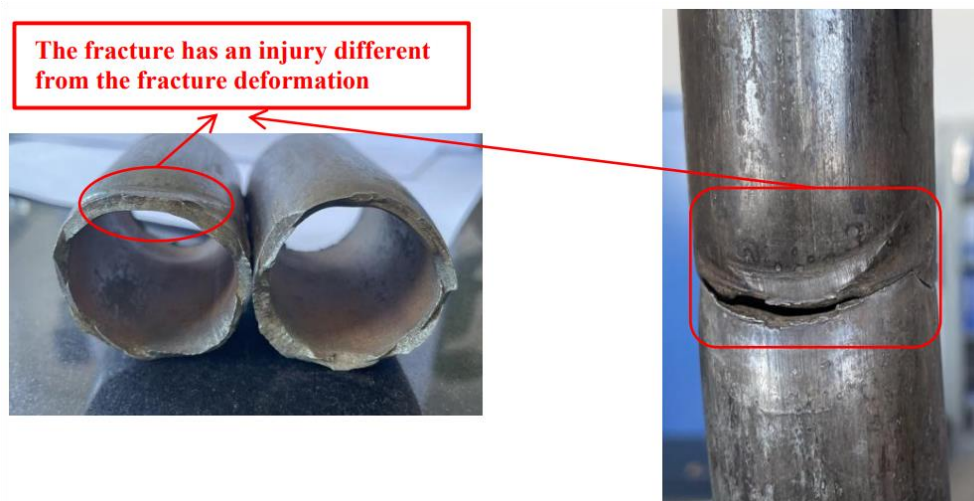
SHINDA (TANGSHAN) CREATIVE OIL & GAS EQUIPMENT CO., LTD produced a disc of  $\phi 38.1 \times 3.2$  ST90 coiled tubing with a length of 2300 meters, fracture occurs during operation. The fracture position was 1078 meters, and the customer ran the well for a total of 7 times.

**Figure 2.** Overall morphology of fracture

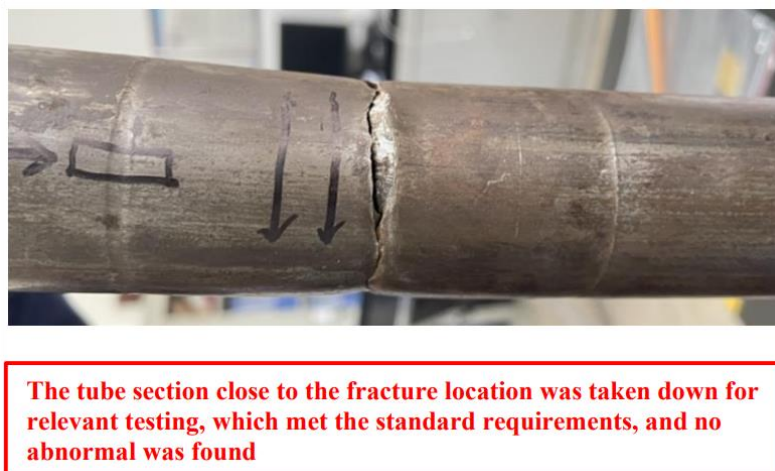
**Figure 3.** The location near the fracture

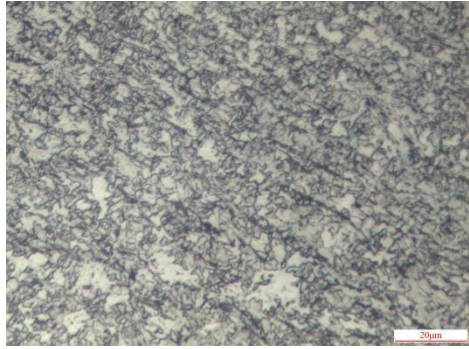
Cut off a section of tube ring near the A2 fracture, for A2, YJ-2000 metallographic microscope and image analysis system were used to conduct grain size analysis according to ASTM E112-2013 standard. The results are shown in Table 3. The results show that the grain size of the sample meets the technical requirements, metallographic structure was not abnormal.

**Figure 4.** Base material

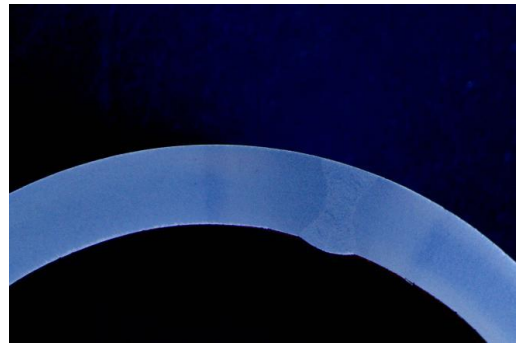
**Figure 5.** Macroscopic surface of metallographic

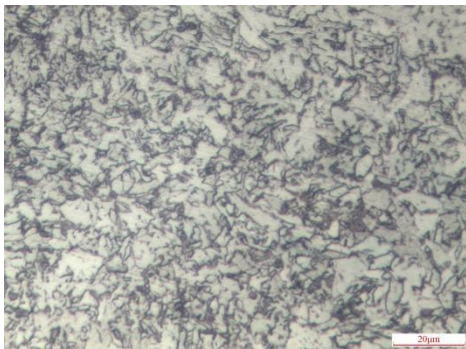
**Figure 6.** Weld 500X

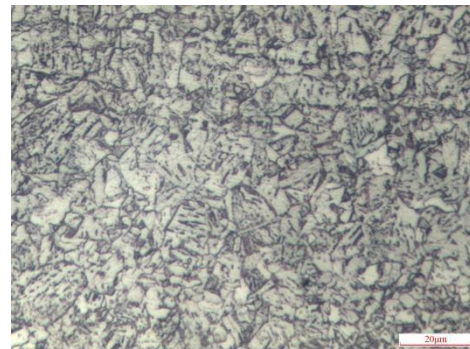
**Figure 7.** HAZ 500X

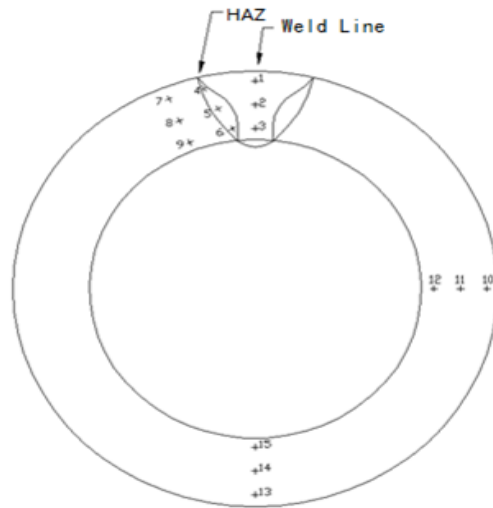
**Figure 8.** Through-wall Hardness Test Impression

Cut off a section of tube ring near the A2 fracture, for A2, 200HVS-5 digital display small-load Vickers hardness tester was used to perform the hardness test according to ASTM E384-22 standards, and the hardness conversion was performed according to ASTM E140-2012b (2019) e1. The hardness test position of the original tube is shown in Figure 7, and the data are shown in Table 4. The results show that, the hardness data meet the technical requirements and the hardness is uniform.

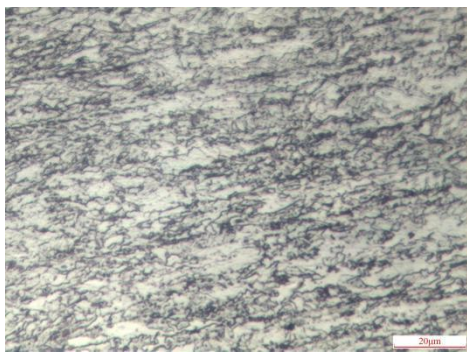
Sample the area of the A1 tube containing the injury, YJ-2000 metallographic microscope and image analysis system were used to conduct grain size analysis according to ASTM E112-2013 standard. [1] The results are shown in Table 5. The results show that the grain size of the sample meets the technical requirements, However, the wall thickness at the damaged site became thinner and deformed.

**Figure 9.** Base material

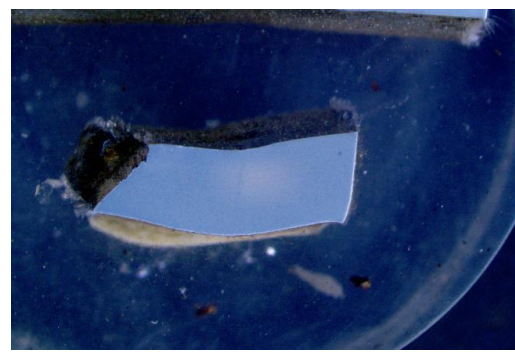
**Figure 10.** Macroscopic surface 6.8X

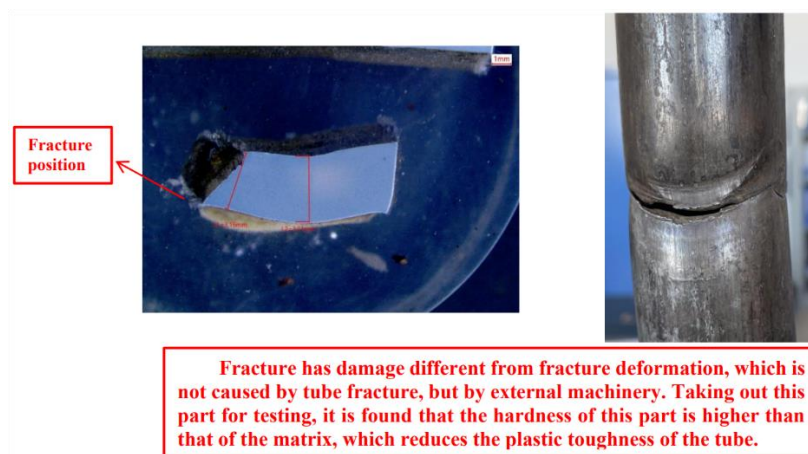
**Figure 11.** The macroscopic picture shows obvious deformation and the wall thickness at the breaking point is reduced 6.8X

We suspected improper operation on both sides of the fracture position, which causes the tube body damage by the stacking of the clamping blocks, that will cause the deformation of the coiled tubing. The thinning of the wall thickness and the increase of hardness will reduce the strength of the tubing [3], which is the main reason for the fracture of the coiled tubing.

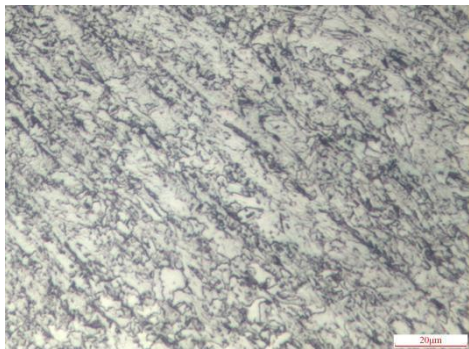
Sample A2 was sampled at the location of the tube side damage that may have been caused by the clamping block, [2] YJ-2000 metallographic microscope and image analysis system were used to conduct grain size analysis according to ASTM E112-2013 standard. The results are shown in Table 6. The results show that the grain size of the sample meets the technical requirements, However, the wall thickness at the damaged site became deformed.

**Figure 12.** Base material 500X

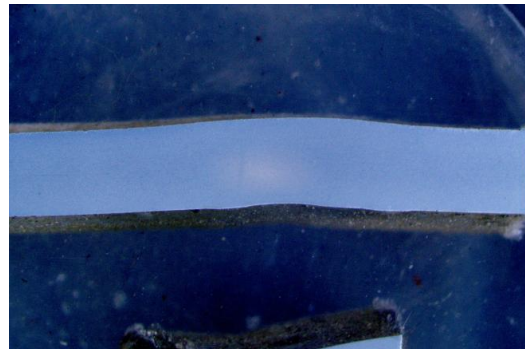
**Figure 13.** Macroscopic surface 6.8X

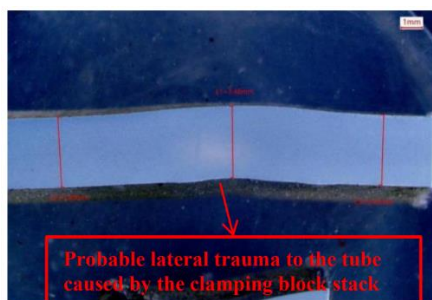
The lateral trauma to the tube caused by the clamping block stack is the same, such mechanical trauma will reduce the plastic toughness of the tube, so that the tube has the risk of fracture.

**Figure 14.** The macroscopic picture shows the wallthickness at the damaged site became deformed 6.8X
