# Study on Corrosion Regularity and Mechanism of a Gathering and Transportation Pipeline in Jiyuan Oilfield

Aiming at the serious problem of corrosion of surface pipelines in Jiyuan Oilfield, this paper analyzes the corrosion law and corrosion mechanism of a gathering pipeline in Jiyuan Oilfield based on a variety of experiments. Research shows: through the spectrometer on the sampling pipe L245N composition analysis shows that the main elements of the pipeline tubing to meet the national standard requirements; the analysis of corrosion products and bacterial species shows that the corrosion type of this gathering pipeline is mainly CO<sub>2</sub> corrosion and bacterial corrosion; based on the corrosion hanging experiment, it can be seen that the temperature in the temperature range of 10°C~50°C, with the increase in temperature corrosion rate becomes larger, the pressure on the pipeline corrosion rate has less impact; based on the results of water quality analysis and pipe corrosion microscopic morphology observation, the pipeline extracted water Cl<sup>-</sup> ion content is high, there is pitting corrosion, especially weld corrosion is more serious.

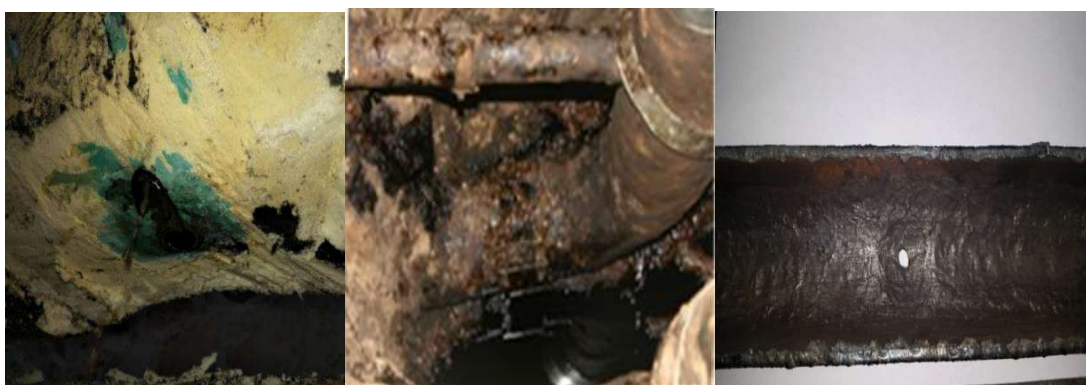
As Changqing No. 3 Oil Recovery Plant enters the middle and late stages of exploitation, the average water content rate increases year by year (currently up to 65%), making the amount of water extracted increase with each passing year, leading to more and more prominent pipeline corrosion, resulting in the pipeline maintenance workload and costs increase every year[7]. In the first half of 2024, the statistics of corrosion in the Dashuikeng Operation Area of Oil Production No.3 Plant are shown in Table 1. Whether it is crude oil gathering and transmission, or sewage reinjection, pipeline corrosion and perforation seriously impede the normal production of oilfields[8,9]. Pictures of pipeline corrosion perforation are shown in Figure 1. In addition, since the utilization rate of L245N steel pipeline in Dashuikeng Operation Area of Changqing Oil Producing Plant No.3 is more than 90%, it is necessary to study the corrosion mechanism that causes corrosion of L245N steel pipeline[10,11].

**Figure 1.** Corrosion perforation pictures

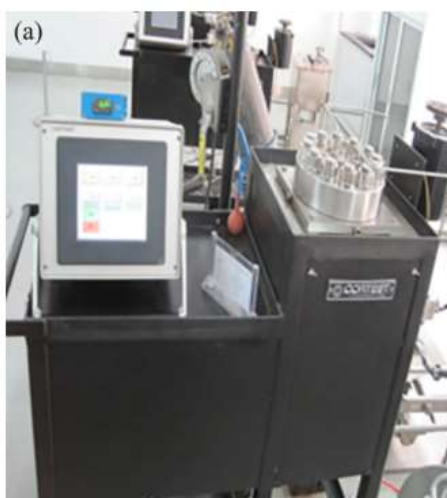
The experimental setup uses a high-temperature and high-pressure reactor as shown in Figure 2. The operating temperature of the oil field pipeline is between 10°C~50°C, the experimental pressure is 1.0Mpa, the fluid rate is controlled at 1.5m/s, and the corrosion rate versus temperature curve is shown in Figure 3.

**Figure 2.** High-temperature and high-pressure dynamic reactor experimental device

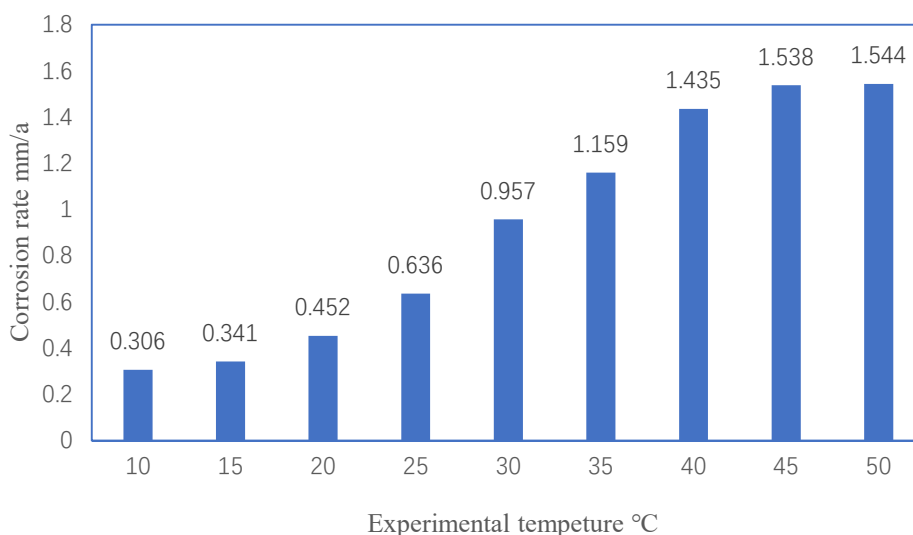
**Figure 3.** Effect of temperature on the corrosion rate of pipelines in the Dashuikeng Operation Area

The operating temperature of the pipeline at the site is 10°C~50°C. The high-temperature section of the pipeline is mainly concentrated in the front section of the pipeline, which is seriously corroded at the site. This is because when the operating temperature is 25°C, the uniform corrosion rate of the

pipe is only  $0.636\text{mm}\cdot\text{a}^{-1}$ . When the temperature exceeds  $25^{\circ}\text{C}$ , the uniform corrosion rate increases rapidly and can reach  $1.544\text{mm}\cdot\text{a}^{-1}$  at  $50^{\circ}\text{C}$ . As a result, pipelines operating at higher temperatures in the range of  $25$  to  $50^{\circ}\text{C}$  are subject to severe corrosion. The uniform corrosion rate of the pipe decreased from  $1.544\text{mm}\cdot\text{a}^{-1}$  to  $1.538\text{mm}\cdot\text{a}^{-1}$  when the operating temperature of the pipe was decreased from  $50^{\circ}\text{C}$  to  $45^{\circ}\text{C}$ , and to  $1.435\text{mm}\cdot\text{a}^{-1}$  when the temperature was decreased from  $50^{\circ}\text{C}$  to  $40^{\circ}\text{C}$ . The increase in corrosion rate slows down when the temperature exceeds  $40^{\circ}\text{C}$ .

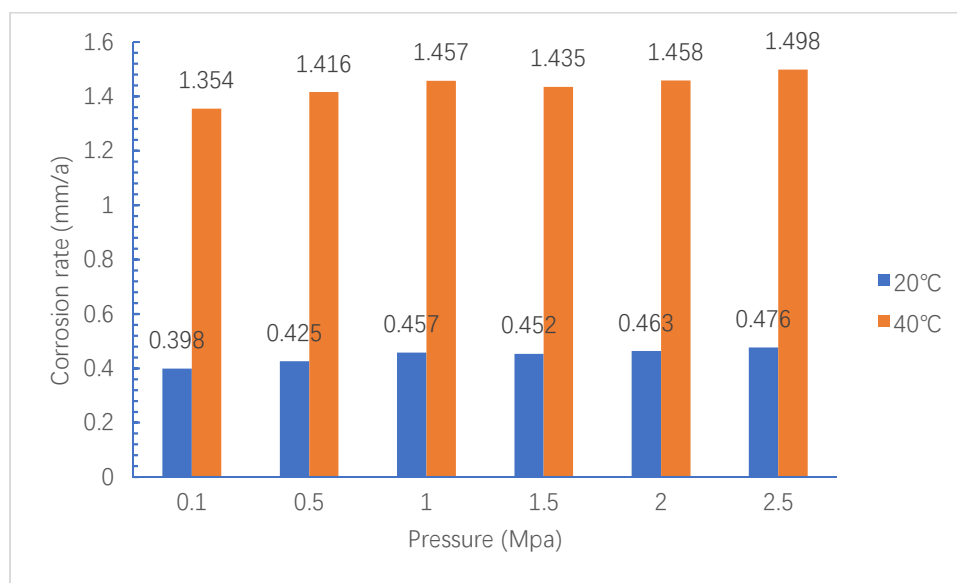
The operating pressure of the oil and gas pipeline of the Changqing oilfield No. 3 oil recovery plant is  $0.1\sim 2.5\text{Mpa}$ , the temperature conditions are fixed, and the temperatures are taken to be  $20^{\circ}\text{C}$  and  $40^{\circ}\text{C}$ , respectively, and the fluid rate is controlled to be  $1.5\text{m/s}$ , through the hanging piece of the experiment to verify the pressure on the pipeline corrosion rate of the pressure was taken as  $0.1\text{Mpa}$ ,  $0.5\text{Mpa}$ ,  $1.0\text{Mpa}$ ,  $1.5\text{Mpa}$ ,  $2.0\text{Mpa}$ ,  $2.5\text{Mpa}$  for the determination of corrosion rate, the experimental results are shown in Figure 4.

**Figure 4.** Corrosion rate versus pressure curve

It can be seen from Table 4 that: the corrosion rate does not change much with pressure, the red color in the figure is the corrosion rate versus pressure curve at a temperature of  $40^{\circ}\text{C}$ , and the blue color is the corrosion rate versus pressure curve at a temperature of  $20^{\circ}\text{C}$ . The trends of the two curves are essentially the same, the corrosion rate is larger when the temperature is high, and the effect of temperature on the corrosion rate is more obvious. The overall effect of pressure on the corrosion rate is that the corrosion rate does not change much with the increase of pressure, but increases slightly. And, as the pressure increases, the fluid velocity increases, which will increase the corrosion rate of scour corrosion, but the pressure has little effect on the corrosion rate in this pipeline steel working pressure range.
