DIC Analysis of Prefabricated Fractured Coal Specimens under Stepwise Constant-Amplitude Cyclic Loading

College of Energy Science and Engineering, Henan Polytechnic University, Jiaozuo, China

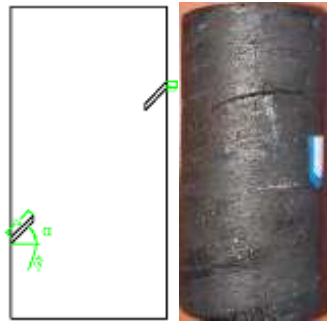
fractures with an inclination angle of $\alpha=45^\circ$, length $2a=10\text{mm}$, and width $2b=0.5\text{mm}$ in the test specimens. As shown in Figure 1.

Figure 1. Sample specification

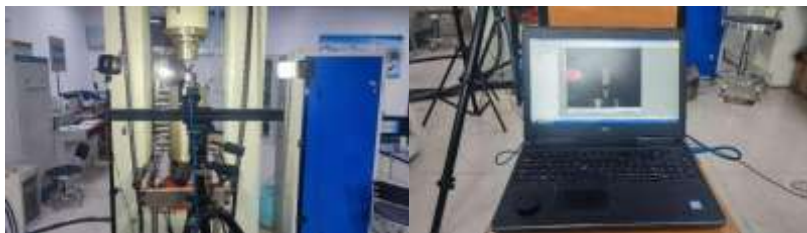
The tests were conducted using an RMT-150C electro-hydraulic servo-controlled rock testing system with a maximum axial load capacity of 100 kN. The axial displacement transducer had a maximum range of 5 mm. Force-controlled loading was applied at a rate of 1 kN/s. The tests employed a VIC-3DHS dynamic non-contact full-field strain measurement system, as shown in Figure 2. The VIC-3DHS is an advanced experimental measurement device that utilizes high-speed photography and digital image correlation (DIC) technology to measure full-field displacement and strain of materials or structures under static or dynamic loading. Developed by CSI (Correlated Solutions, Inc.) in the United States, this system is suitable for mechanical property testing of various materials, including rock, metal, plastic, composite materials, and biological tissues.

Figure 2. VIC-3D HS Dynamic Non-contact Full-field Strain Measurement System

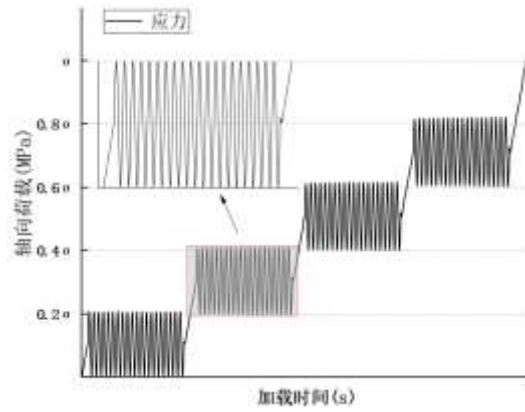
The average peak strength σ of the specimens was determined through conventional uniaxial compression tests, which was then used to establish the upper and lower limits for the stepwise constant-amplitude cyclic loading tests. Starting from an initial stress of 0 MPa, cyclic loading was applied in increments of 20% of the average peak stress (σ), with cyclic upper limits set at 20%, 40%, 60%, and 80% of σ . The upper stress limit of each loading cycle served as the lower stress limit for the subsequent stress level. Based on field monitoring data of mining truck loads, blasting, and tunnel excavation, along with relevant research findings, a cyclic loading frequency of 0.2 Hz was adopted in this test. To investigate the repeated loading-unloading process experienced by coal under multi-step/mining disturbance, 20 cycles were applied at each stress level. The stress path of the designed stepwise constant-amplitude cyclic loading test is illustrated in Figure 3.

Figure 3. Axial load-time curve
