Analysis on Bridge Collapse Accidents Caused By Rainfall and Flood: A Case Study of Xiaoqing River Bridge

Abstract. This paper studies the structural integrity and ecological impact of Xiaoqing River Bridge in Beijing. Xiaoqing River Bridge is an important urban infrastructure spanning the Xiaoqing River, an important tributary in Beijing. Featuring a unique French design and reinforced concrete T-shape, the bridge has served a variety of urban functions for more than 40 years, including flood control and urban landscape improvement. However, the challenges posed by rapid urbanization and climate change, especially the increasing frequency and intensity of flood events, make it necessary to reassess the structural resilience and ecological impact of bridges. This paper analyzes the engineering background of the bridge, focuses on the combination of traditional and modern engineering of the bridge, and the adaptive measures taken to improve the bearing capacity and flood resistance of the bridge. The application of advanced materials and technologies in river management and ecological restoration was discussed, and the importance of environmental sustainable development and ecologi

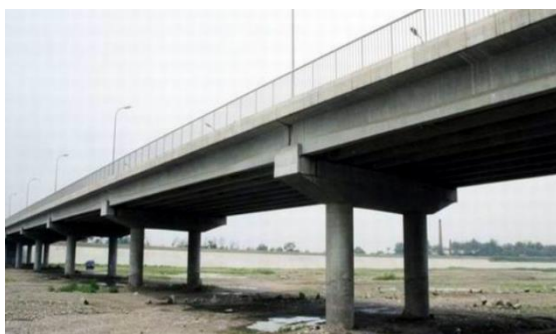
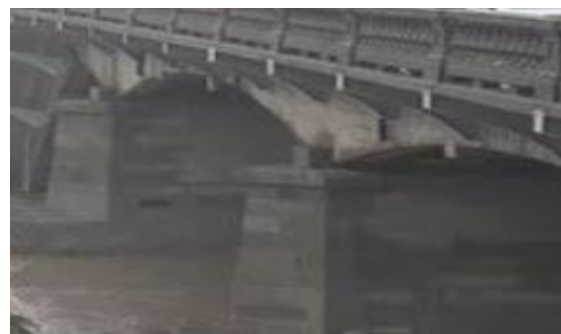
Figure 1. South Side Structural changes of Xiaoqing River Bridge caused by changes in time [3, 4]

(a) Bridge structure in 2013

(b) Flood discharge on July 30,2023

As illustrated in Fig. 1, side-by-side images of 2013 with the recent Xiaoqing River Bridge show the evolution of bridge architecture. The original arch support system was strategically modified to add additional beams across the pier or abutment, enhancing the bearing capacity of the bridge and transferring the mechanical stress directly to the support structure. This adaptive change is crucial to strengthen the bridge against the continued impact of floods.

Combined with the content of Fig. 1, that can further understand the impact of these structural changes on the overall performance of the bridge. Bridge span structure may refer to the main structure of the bridge, including the bridge deck and its supporting structure, which echoes the T-shaped bridge structure mentioned in Fig. 2. Abutment support and piers are key parts of the bridge structure that support the bridge and transfer the load to the foundation. The carrying capacity of these structures is enhanced by adding additional beams. Foundation is to support the bottom structure of the entire bridge structure, to ensure the stability of the bridge. Cone slope protection and embankment may be the structures that protect the slopes around the bridge from erosion and the embankments on the banks of the river to control the water flow and protect the bridge.

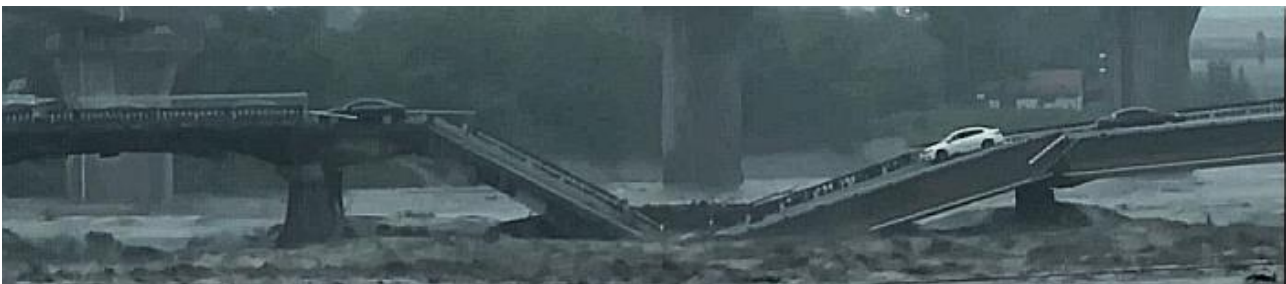
Figure 5. Xiaoqing River Bridge Field pictures of the fracture point [6]

The massive collapse caused by flood, hydraulic pressure and heavy rain highlights the serious collapse behavior in the center of the third section of the bridge under the extreme hydraulic action. It fully reflects that the bridge has a serious uneven force on the opposite side of the flood, making the central position a vulnerable point, as shown in Fig. 4. When the flood with huge flow cannot withstand the action of vehicle force and pressure force, the interaction of force will squeeze the bridge collapse phenomenon, as shown in Fig. 5.
