# Study on Microstructure and Properties of LZ50 Axle Steel Repaired by Laser Additive Remanufacturing

**Abstract.** ER308L stainless steel welding wire was used for laser repair of LZ50 train axle steel sample. A large number of defects, such as microcracks, pore shrinkage and porosity, can be found in the re-manufacturing sample. A wave-like structure was formed at the boundary of the fusion zone between the augmented repair material and the base material, and the structure in this zone was consist of about 83% martensite and about 17% austenite, In the ER308L stainless steel welding wire repair zone, columnar equiaxed crystals with different lengths and morphology were formed, all of which pointed to the center of the molten pool. After repair, the tensile strength of the specimens decreased from 601.34MPa to 427.81MPa, and the elongation decreased from 16% to 5%, The fracture mode was a combination of ductile fracture and brittle fracture.

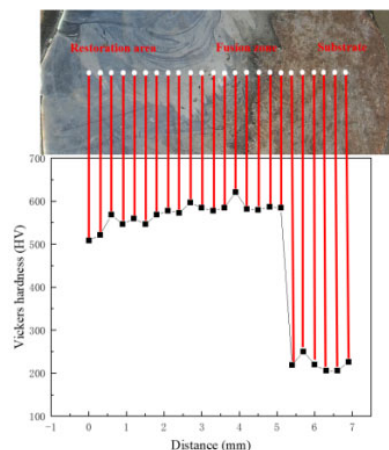
As shown in Figure 6, the hardness test data is measured with a distance of 0.3mm along the direction perpendicular to the laser additive remanufacturing direction. The hardness value of the base material is about 150~250 HV, with an average value of 176.8HV. The Vickers hardness of the remanufacturing area is roughly between 500 and 600, and its average value is about 534.8HV. The higher hardness value in this area is due to the martensite formed at a high cooling rate [6]. There is a large gap between the hardness of the base material and the remanufacturing area. In practical use, due to the high hardness gap will weak the mechanical properties.

**Figure. 6** hardness profile

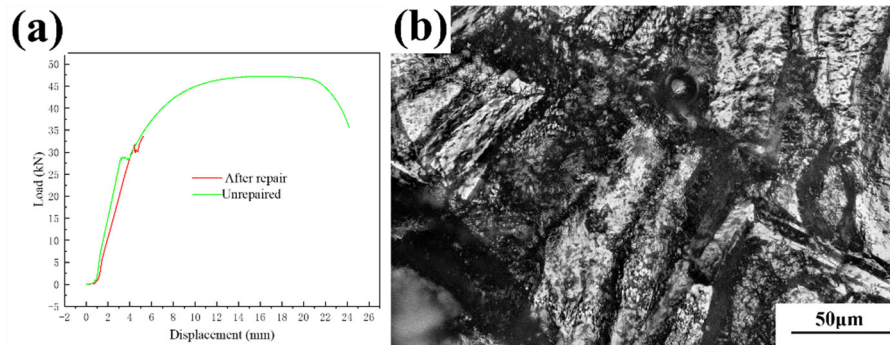
Figure 7 (a) shows the tensile curve of LZ50 axle steel. It can be seen, after the fracture of elastic stage, yield stage, strengthening stage and neck stage, the yield strength of remanufacturing sample increased from 359.95MPa to 401.07MPa, and the tensile yield limit of remanufacturing sample increased by 11.4% than that of original sample, and the tensile strength decreased from 601.34MPa to 427.81MPa, and the elongation decreased from 16% to 5%. The main reasons are: cracks, pores and other welding defects in the materials, the surface of the remanufacturing sample is not smooth enough and the caused residual stress in the samples. Cracks first appear from the defects in the remanufacturing zone without obvious plastic deformation, and then the cracks extend to the base metal and fracture occurs. As shown in Figure 7 (b), for the fracture morphology of the

remanufacturing sample, tear ridge and cleavage step can be observed. The fracture mode of the sample is a combination of ductile fracture and brittle fracture.

**Figure. 7** Tensile curve and stretch section, (a) Tensile curve and. (b) Stretch section
