Development of a Vibration-based Experimental Platform for Diagnosing Gear Pitting Failure in Reducers

Abstract. Gear pitting failure in the reducer has a significant impact on the normal operation and transmission efficiency of the equipment. In this paper, a vibration-based experimental platform for diagnosing gear pitting failure in reducers is developed. The platform aims to simulate gear pitting failure conditions and analyze vibration signal characteristics. Through the validation of experimental results, this paper demonstrates that analyzing vibration parameters such as clearance, impulse, peak value, and vibration intensity, combined with the multiple relationship between fault frequency in vibration spectrum and gear meshing frequency, can accurately determine the type and location of gear failure in the reducer. Furthermore, the experimental platform can simulate gear vibration under different speeds and loads, providing a foundation for accurate diagnosis and identification of gear failures. The developed experimental platform has significant practical value and can provide technical support for the prevention and maintenance of gear failures in reducers.

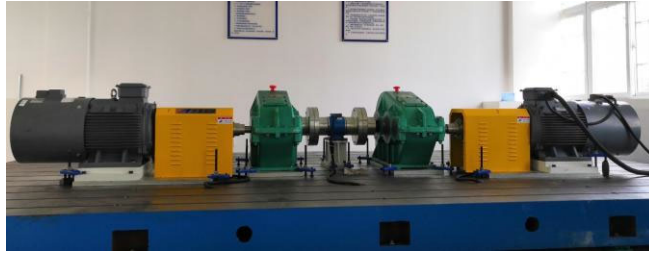
The test bench is shown in Figure 1, which is composed of six major systems, namely 1) Support system, 2) Power system, 3) Acceleration deceleration system, 4) Connection system, 5) Load system, 6) Control system, 7) Sensing system, 8) Output and display system.

Figure 1. Speed reducer fault diagnosis test bench

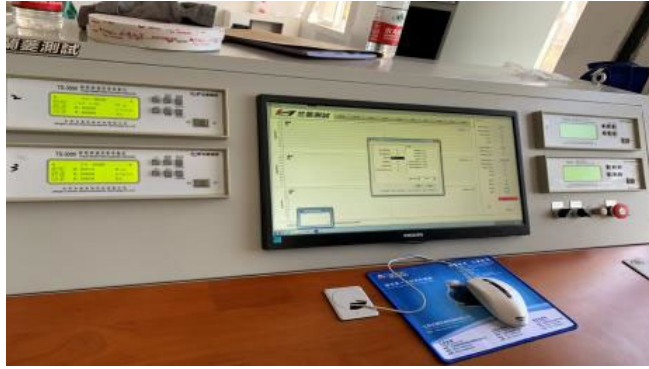
The output and display system consists of two parts: the sensor direct output signal display system TS3000 torque, speed, and power acquisition instrument, and the display monitor connected to the computer for signal acquisition. The display monitor can display parameters and load conditions in different sections, and can also draw real-time curves. The output and display system are shown in Figure 2.

Figure 2. Output and display system

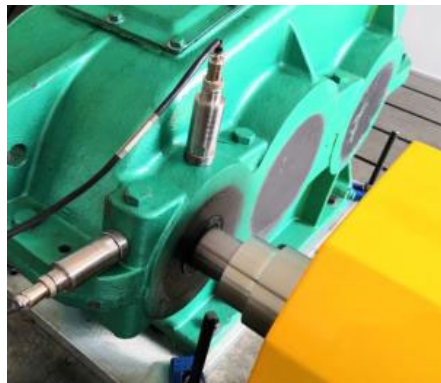
and on-site data acquisition of vibration data is performed. The horizontal and vertical directions of the bearing seat for the high-speed shaft of the gearbox during data acquisition can be seen in the arrows in Figure 4. Figure 5 shows the layout of measurement points. Vibration detection sensors are attached to the bearing seat in the form of magnetic holders and arranged orthogonally.

Figure 5. Field vibration data acquisition measurement point arrangement

Layout of measuring points: see Fig. 4 and Fig. 5.
